Tree Condition Survey and Management Work Recommendations

Date – 15th November 2017

Site – Panteg, Ystalyfera (Full Report)

Project Reference – ArbTS_385.2_Pantteg

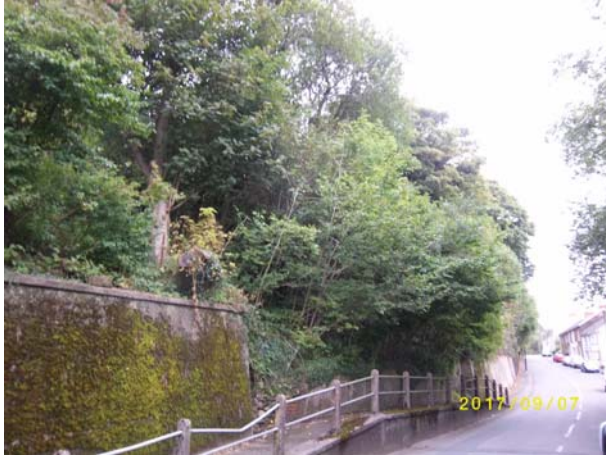
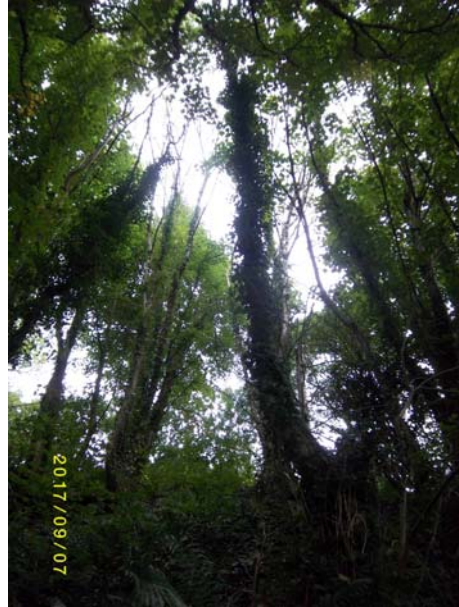
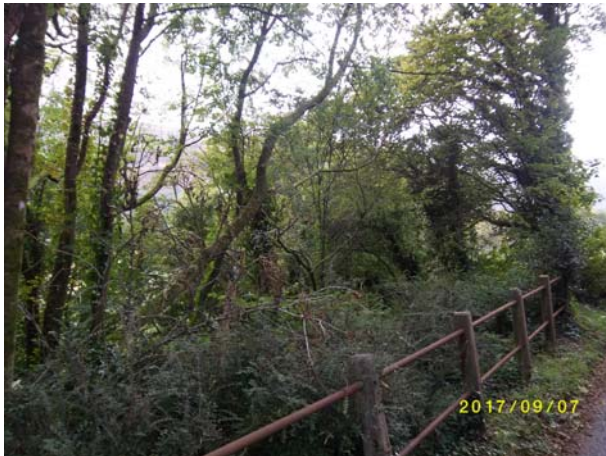
Tree ID#G1

Tree ID #	Tree Species	Age	Size	Physiological Condition	Structural Condition	Comments	Management Work Recommendations	Target Occupation	Work Type	Work Priority
Tree Data										
G1	Acer pseudoplatanus (Sycamore), Ulmus procera (English Elm), Fraxinus excelsior (Ash)	M	M/L	Fair	Fair	tree group, eastern area in group consists of trees grown together on steep bank of approximately 60degrees with some areas of loose surface soil / gravel noted, large drop at bottom of bank onto Cyfyng road, some larger sycamore multi-stemmed in form noted, small slender sycamore and elm noted between larger trees, trees have grown together as a group, some trees appear to have been possibly past coppiced, a number of slender tall ash noted at top (north side) of bank with no or very sparse leaf cover likely caused from ash die back, western area of group consists of some individually identified tree in the survey area and some medium sized sycamore and smaller goat willow shrub noted	due to the location of the trees on a steep bank with a large drop down to the road it is recommended that the trees in this area are coppiced to 1 metre high stumps , tree species likely to regenerate to retain structural benefits of tree roots stabilising the area, coppicing tree will significant reduce ground movement from swaying of trees in strong winds, further to this with the likely loss of ash trees noted in the north eastern part of the group this will increase exposure to other trees from their demise which will increase the likelihood of surrounding tree failure, therefore it is recommend that this group is managed as a coppiced whole in perpetuity (10 yearly cycle of coppicing)	Medium	Hazard	Medium

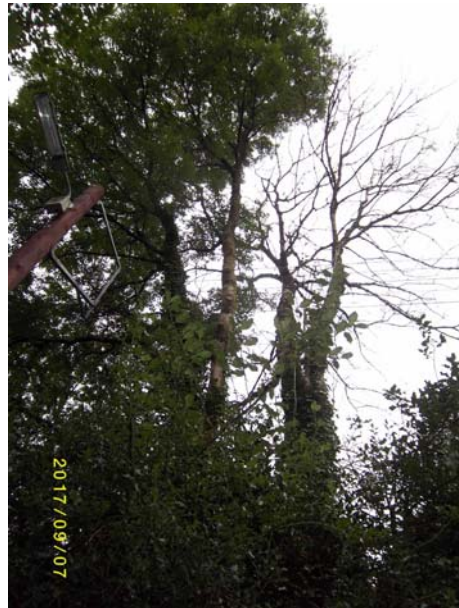
Tree ID#T299

T299	Fraxinus excelsior (Ash)	M	M/L	Poor	N/A	unable to inspect tree due to surrounding vegetation cover, eastern side of crown has no leaf coverd and western side has fair leaf cover, tree id tag on track side electrical post, electrical lines close to trunk, area of chicken huts noted under tree	re-inspect next summer to assess crown health, most likely to not respond and will require felling	M/Low	Hazard	Medium
T300	Fraxinus excelsior (Ash)	EM	S/M	F/Poor	Fair	Low bud/leaf density.	re-inspect in 12months	H/Medium	Hazard	M/Low

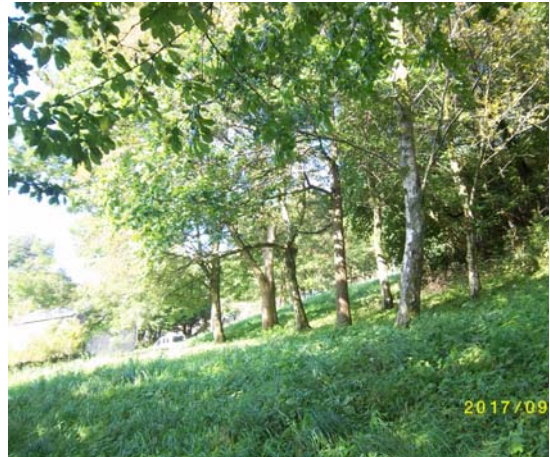
Survey area SA6

SA 6	Fraxinus excelsior (Ash), Sorbus aucuparia (Rowan), Prunus avium (Wild Cherry)	N/A	N/A	N/A	N/A	Surveyed area on 12th September 2017, appears to be a semi formally planted area of trees with grass ground cover, trees located on bank sloping to the south, northern road side trees of higher target occupation than the rest of trees in survey area		H/Medium		
SA 7	Betula pendula (Silver Birch), Acer pseudoplatanus (Sycamore)	N/A	N/A	N/A	N/A	Surveyed area on 12th September 2017, Trees only inspected from road side due to area of thick scrub consisting of road side buddleia. No major trees of note that required access to be obtained.		Medium

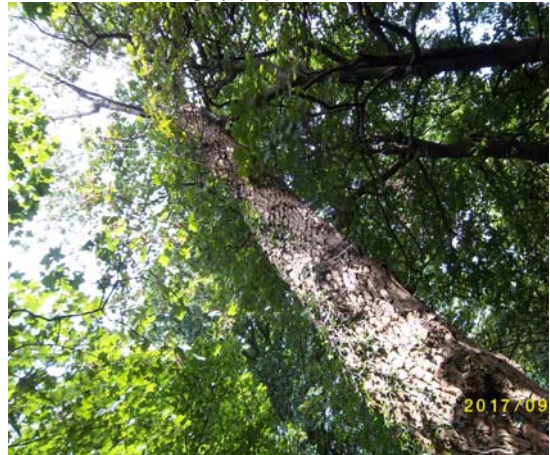
Tree ID#T318 (Hung up poplar tree)

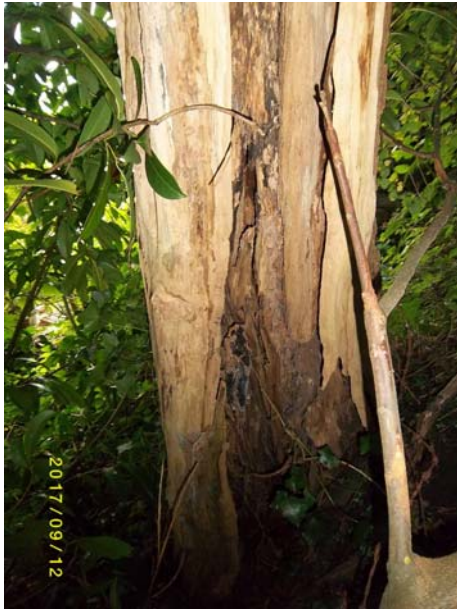
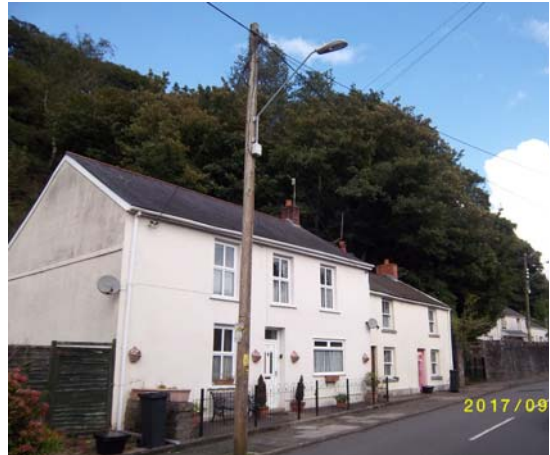
Tree ID#T319 Locust Tree

T319	Robinia pseudoacacia (Locust Tree)	OM	M	Fair	Poor	large split at base, suppressed and slender in form	fell, contact Roger Morris (contact details to be provided) regarding arranging to carry out tree works at Dan y graig	Medium	Hazard	H/Medium
T320	Fraxinus excelsior (Ash)	M	L	F/Poor	F/Poor	ash tree appears in poor health, only limited leaf cover noted in crown, maybe be due to early autumn leaf drop or ash die back disease	re-inspect next summer to assess crown health, most likely to not respond and will require felling	M/Low	Hazard	Medium
T321	Picea abies (Norway Spruce)	M	M	F/Poor	F/Poor	sparse needle cover	fell	Medium	Hazard	Medium
T322	Fraxinus excelsior (Ash)	M	M	F/Poor	F/Poor	ash tree appears in poor health, only limited leaf cover noted in crown, maybe early autumn leaf drop or ash dieback disease, also small road side ash noted with sparse foliage cover	re-inspect next summer to assess crown health, most likely to not respond and will require felling	M/Low	Hazard	Medium

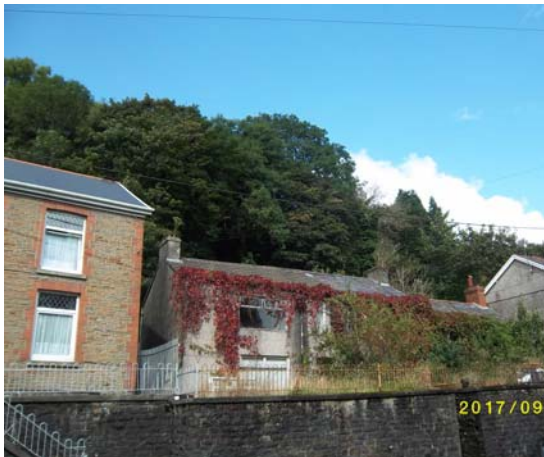
Tree ID#T316 and T317

Tree ID #	Tree Species	Age	Size	Physiological Condition	Structural Condition	Comments	Management Work Recommendations	Target Occupation	Work Type	Work Priority
T316	Fraxinus excelsior (Ash)	M	M/L	Dead	F/Poor	appears to be dead when inspected from adjacent garden, with removal of adjacent sycamore tree it is recommended to remove this tree at the same time	fell	Medium	Hazard	H/Medium
T317	Acer pseudoplatanus (Sycamore)	M	M/L	Fair	F/Poor	area of decay noted on southern and eastern buttress with minor surrounding callus growth and what appears to be buckling on southern side of buttress with predominant weight of tree to the south, leaves slightly small and slightly sparse cover	fell to 1 metre stump to allow to regenerate stem and reduce any exposed lateral branches on adjacent trees to minimise branch failure from removal of tree	Medium	Hazard	H/Medium
T318	Populus spp (Poplar spp)	OM	M	F/Poor	Poor	hung up in southern trees, top appears to have failed, tree located in low target occupied area but possible potential to slide down slope if tree falls to ground level	fell, contact Roger Morris (contact details to be provided) regarding arranging to carry out tree works at Dan y graig	Low	Hazard	H/Medium

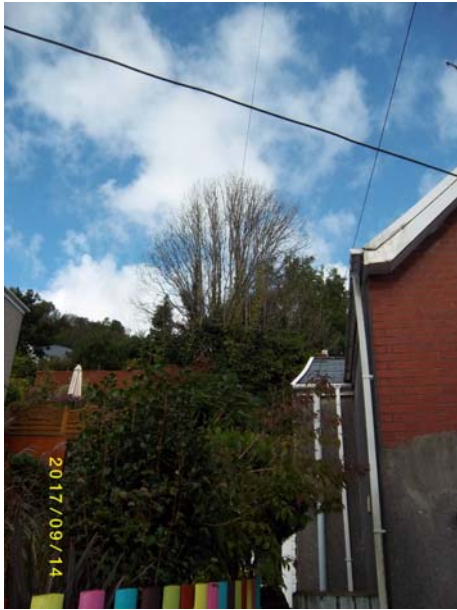
Tree ID#T3

T3	Fraxinus excelsior (Ash)	M	M	Poor	F/Poor	a number of multistemmed ash trees on boundary of properties, trees inspected from a distance from rear garden of number 9 church road, Mr Hinchcliffe of 9 church road informed me that the ash trees were pollard around 15 years ago and that it had sparse small leaf cover during the summer, overhanging rear garden	re-inspect next summer to assess crown health, most likely to not respond and will require felling	Medium	Hazard	Medium
T4	X Cupressocyparis leylandii (Leyland Cyp)	EM	S/M	Fair	Fair	growing through BT lines	fell	M/Low	Arb	M/Low
T5	Salix caprea (Goat Willow)	M	M	Fair	Poor	goat willow with over extended western branch over BT lines and access road	fell	Medium	Hazard	H/Medium
T6	Acer pseudoplatanus (Sycamore)	M	M	G/Fair	N/A	large sycamore in corner of garden of number 1 pantteg , unable to inspect sycamore due to thick surrounding vegetation, crown appears healthy, spoke with Mrs Ann Marie Earland regarding the tree and she had not observed any major issues with the tree		M/Low

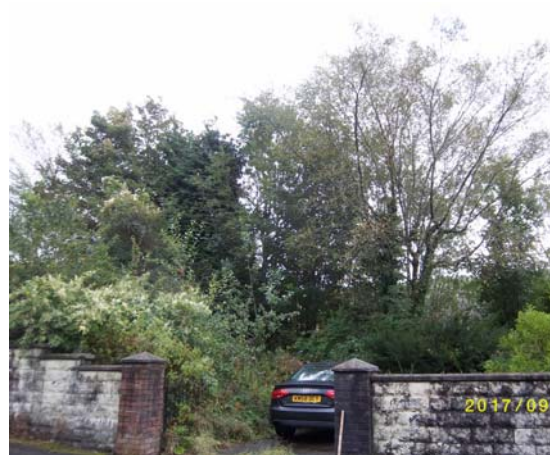
Survey Area SA10

SA 10	Fraxinus excelsior (Ash), Acer pseudoplatanus (Sycamore), Betula pendula (Silver Birch)	N/A	N/A	N/A	N/A	Surveyed area on 14th September 2017, trees inspected from rear garden of number 9 church road; trees on higher northern level, ash identified as possible suffering from ash die back, also inspected from with higher level property, row of multi-stemmed trees from previous coppicing works, high surrounding vegetation and trees located on steep bank limiting the extent of the tree inspection		Medium		
SA 12	Acer pseudoplatanus (Sycamore), X Cupressocypariss leylandii (Leyland Cyp)	N/A	N/A	N/A	N/A	Surveyed area on 3rd October 2017		M/Low		
SA 13	Acer pseudoplatanus (Sycamore), Corylus avellana (Hazel)	N/A	N/A	N/A	N/A	Surveyed on 13th November 2017		Low

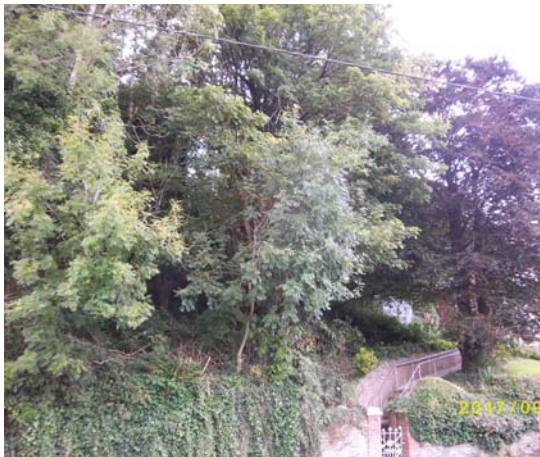
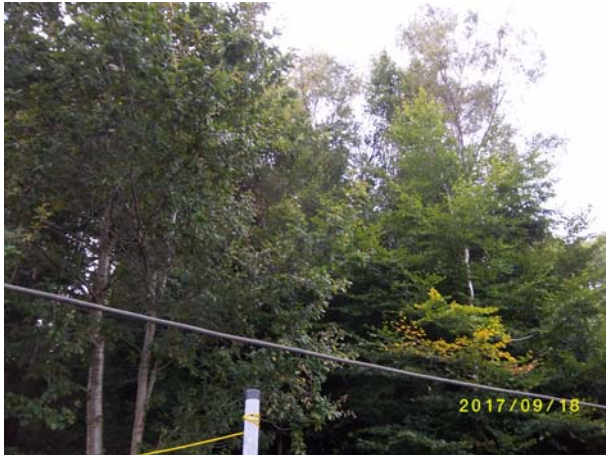
Survey Area SA8

Tree ID #	Tree Species	Age	Size	Physiological Condition	Structural Condition	Comments	Management Work Recommendations	Target Occupation	Work Type	Work Priority
SA 8	Acer pseudoplatanus (Sycamore), Fraxinus excelsior (Ash), Picea abies (Norway Spruce)	N/A	N/A	N/A	N/A	Surveyed area on 18th September 2017, some ash noted in survey area with sparse crown likely to be caused by ash die back disease, some sycamore on northern edge of survey area noted with sparse foliage cover but located in low target occupied area, Occupier of Briardale house informed me that next month fir trees are to be felled, Occupier of Woodlands house informed that some thinning of rear garden/woodland area of conifer, sparse leaf covered ash and goat willow will be carried out.		H/Medium		
SA 9	Taxus baccata (Yew), Fraxinus excelsior (Ash), Salix caprea (Goat Willow), Aesculus hippocastanum (Horse Chestnut)	N/A	N/A	N/A	N/A	Surveyed area on 14th September 2017, area of trees around cemetery boundary and road inspected, western public footpath noted on boundary of survey area, some small ash in this area with signs of ash die back disease		M/Low

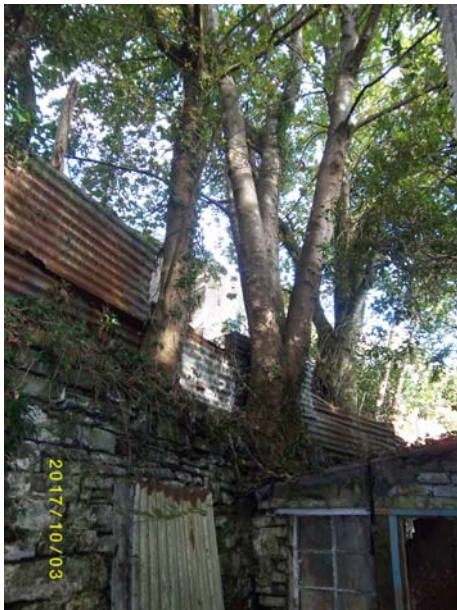
Tree ID#G2

G2	Acer pseudoplatanus (Sycamore), Salix caprea (Goat Willow)	M	M	Fair	Fair	tree group, spoke to Mr Ian graham, owner of whole row 4 to 9 clees lane, he informed me that dwellings to be removed by 1st November, trees behind number 9 growing on top of 2.5 metre old stone retaining wall, multistemmed in form, likely growth from possible previous coppice management	due to demolition work it is recommended that all trees are pollard to 1 metre high stumps	M/Low	Hazard	H/Medium
G3	Salix caprea (Goat Willow)	M	M/L	Fair	Fair	tree group, two goat willow tree adjacent to 9 clee lane, generally short lived species prone to branch stem failure, included bark stem noted on north western tree with some black fungal rhizomorphs from potentially honey fungus noted on northern side of trunk, with the removal of northern tree group (treeID#G2) these trees will be left exposed and a species prone to failure	fell two goat willow	M/Low	Hazard	H/Medium

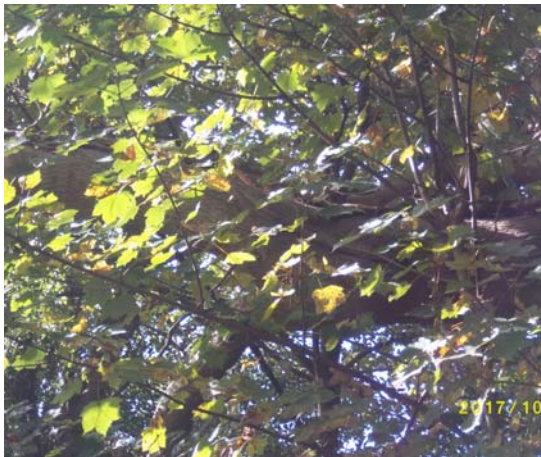
Tree ID#T6 – split in long low lateral branch

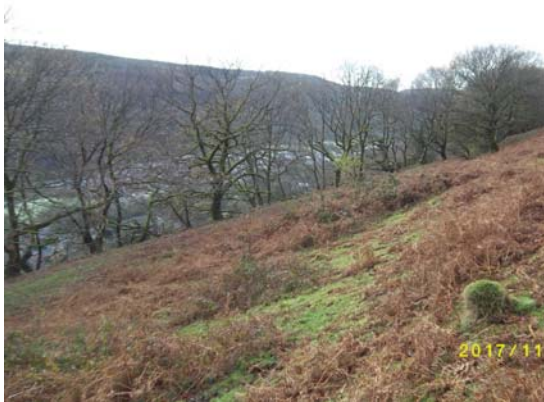
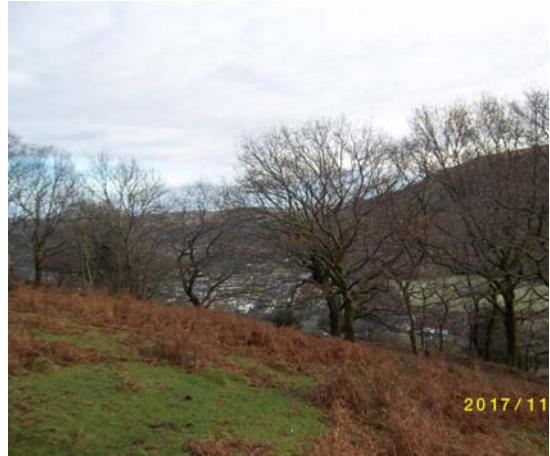
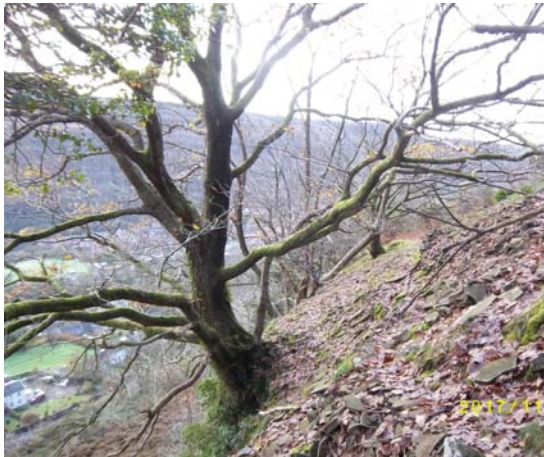
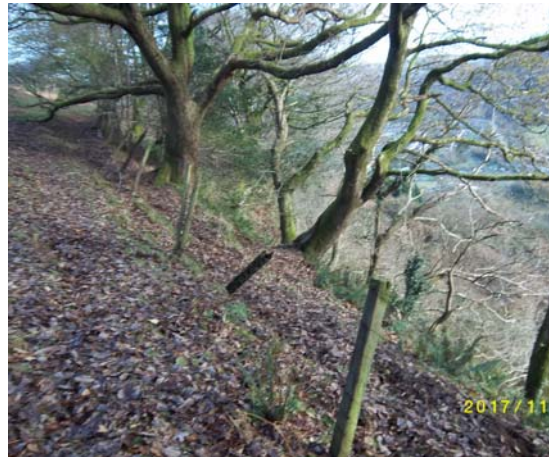
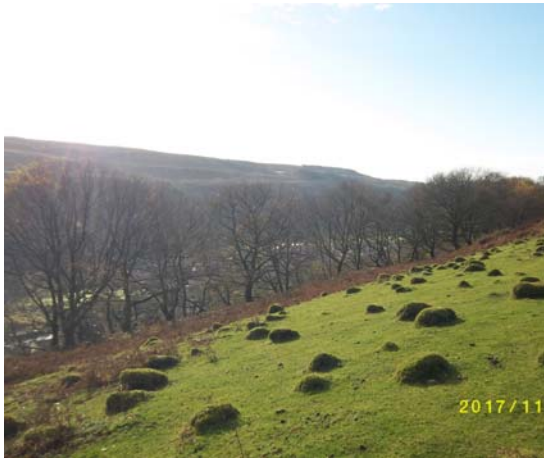
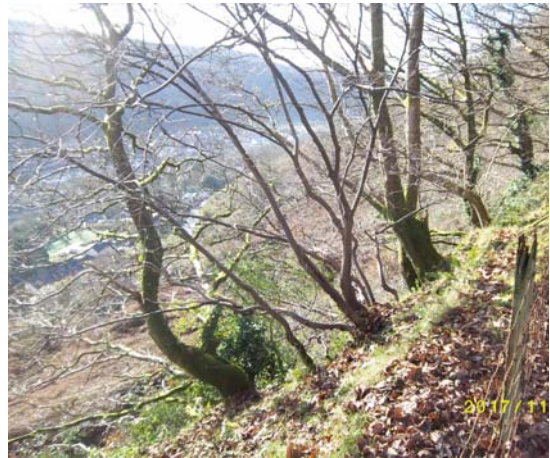
Survey Area #SA1

SA1	Quercus robur (Common Oak), Salix caprea (Goat Willow), Acer pseudoplatanus (Sycamore), Betula pendula (Silver Birch)	N/A	N/A	N/A	N/A	Surveyed on 13th November 2017, Trees located along top of cliff growing from top or side of upper rock face, some areas not safe to access to fully inspect trees, trees inspected from inside of fencing or on paths where access was safe to do so, mainly consisted of large old oaks growing from top of rock face which appear to have adapted growth as required to maintain their structural stability, trees have grown together as a large long group and tree crowns are generally compact in form		Low		
SA2	Salix caprea (Goat Willow), Acer pseudoplatanus (Sycamore)	N/A	N/A	N/A	N/A	Surveyed Area on 4th, 7th, 14th September, 28th October 2017, traversed the southern area near to top of high retaining wall to exit at the near end of the survey area onto the northern lane, trees over 150mm diameter at 1.5metres above ground level inspected adjacent to road with the potential to fall into road, trees inspected where access, vegetation and terrain allows		H/Medium

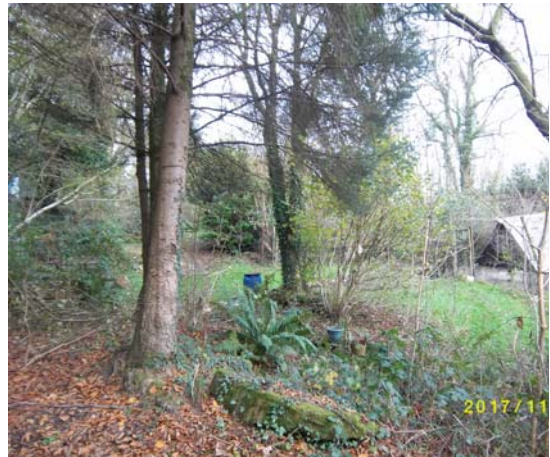
Survey Area #SA14

Tree ID #	Tree Species	Age	Size	Physiological Condition	Structural Condition	Comments	Management Work Recommendations	Target Occupation	Work Type	Work Priority
SA14	Aesculus hippocastanum (Horse Chestnut), Pinus sylvestris (Scots Pine), Salix caprea (Goat Willow)	N/A	N/A	N/A	N/A	Surveyed on 13th November 2017, only trees around dwelling inspected where access allows		M/Low		
SA 15	Corylus avellana (Hazel), Salix caprea (Goat Willow)	M	S/M	Fair	Fair	Surveyed on 3rd October 2017, mainly consists of elapsed hazel coppice and some goat willow, some medium sized ash and sycamore noted near to southern edge of survey area		Medium		
SA 16	Salix caprea (Goat Willow), Acer pseudoplatanus (Sycamore), Corylus avellana (Hazel), Fraxinus excelsior (Ash)	M	M	Fair	Fair	Surveyed area on 3rd October 2017, mainly consists of elapsed hazel coppice and some willow and sycamore and large ash, may be located outside of study area		M/Low
